# Manhole Inspection Summary

Manhole # S25EE1003MH

Insp Date: **1/25/07 1:35 PM**

**Location** Address: **3846 FALLS RD**

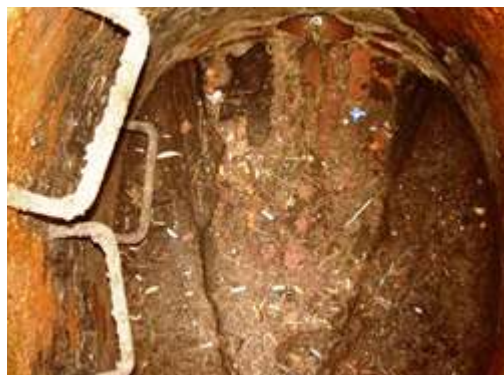
Top View

Bench and Channel debris.

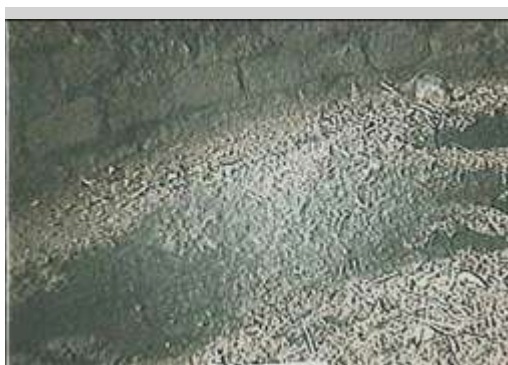
Defect

Barrel deterioration and infiltration.  
Channel root intrusion.

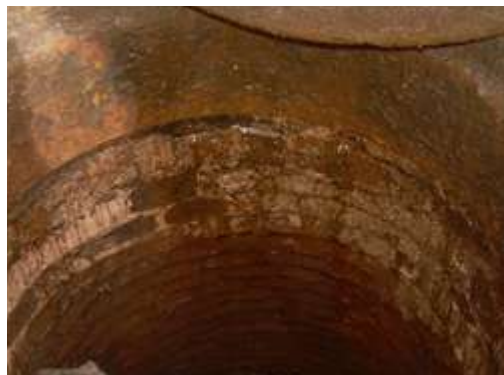
Defect

Frame leaks. Adjustment deterioration  
and infiltration. Corbel infiltration.

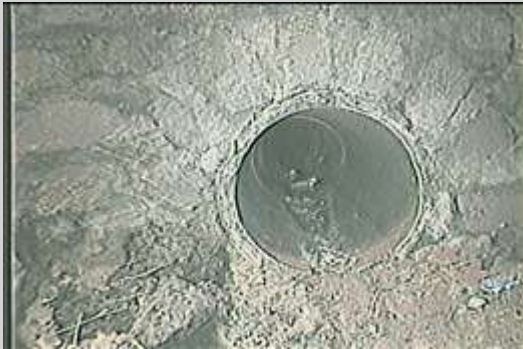
8 in. Circular Gravity Sewer  
Pipe Out @ 12 O'Clock

Deposits: ☐ None ☒ **Mud** ☐ Sludge ☒ **Debris** ☐ Grease

Silt Depth: **0.5** (in.) Deposits Extent: **Light**
